**Flood Control Project Maintenance  
Levee Inspections**

**Fall 2016 Levee Maintenance Deficiency Summary Report**

**Sacramento River Basin**

**Yolo County Service Area 6**

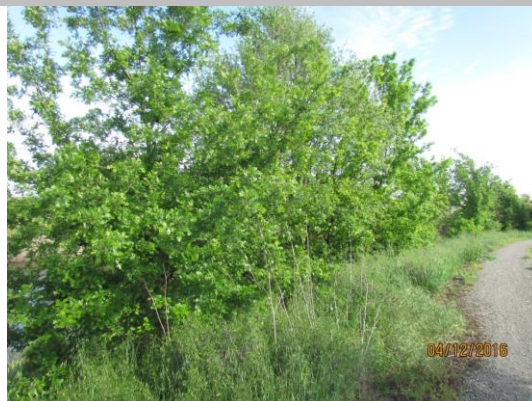
Photo 1 of 1 : FA\_2016\_NA0022\_350\_66\_20160913\_00047.jpg

View of the oak trees on the waterward side of the levee looking downstream. Spring 2016.

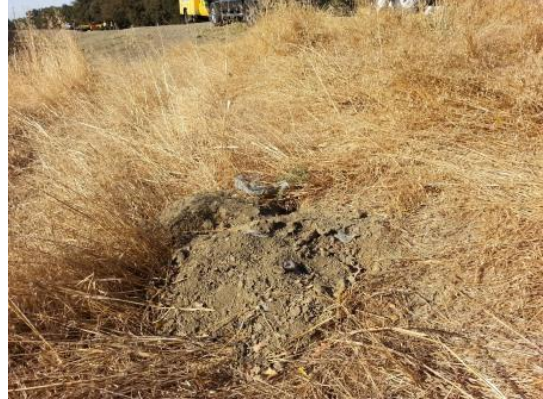
Photo 1 of 1 : FA\_2016\_NA0022\_350\_64\_20161010\_00148.jpg

LM Start	0.01	Rating **	U	Issue No.	64
LM End	0.01	Issue Type +	Ma	Location *	LS
Category	Earthen Levee			GPS Latitude/Longitude	
				Start	End
Item	Animal Control			38.799215 °	38.799215 °
				-121.724341 °	-121.724341 °
DWR ID	DWR_NA0022_01_f _ 2016_64				
Comment Code					
A3 : No rodents visible, but rodent burrows visible; need to backfill and compact or grout burrows.					
Inspector Comment					
More than 2 cub.ft of soil observed around the burrow.

Rodent burrow on LS slope of the levee across from Outfall Gates. Fall inspection 10/07/2016.

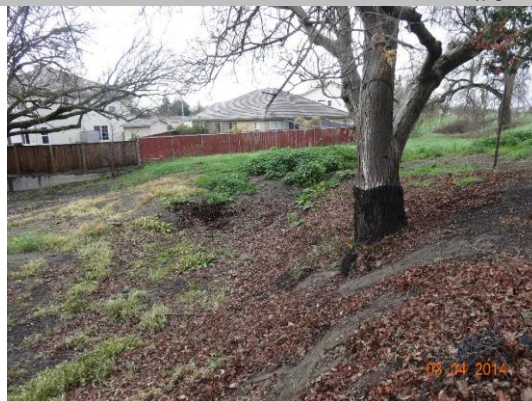
Photo 1 of 2 : UCIP\_FA\_2016\_31903\_58222.jpg

LM Start	0.13	Rating **	M	Issue No.	396
LM End	0.13	Issue Type +	En	Location *	LS
Category	Supplemental			GPS Latitude/Longitude	
				Start	End
Item	DWR UCIP Field Study			38.800647 °	38.800647 °
				-121.723212 °	-121.723212 °
DWR ID					
Comment Code					
Inspector Comment					
FS_ID:31903 DS_ID:19515 EP_NO: 9425 Repair Type: Non-Urgent Crossing Status: Found UCIP Comments: Need to properly abandon crossing per Title 23-- pipe has been disconnected. No signs of pipe visible on waterward and landward sides. Need to contact owner to determine additional information about pipe section through levee. FIELD_STRUCT_DESC: *ABANDONED* 8-inch steel irrigation pipe through the levee, 3.0-feet below the crown. Pump structure in channel. (Automatic Board Order (ABO) issued as Permit No. 9425, 1974 - Nuttall). [Additional Reference(s): DWR Levee Log, 1990 and 2005]. FS Date: 3/4/2014

View of landward side.

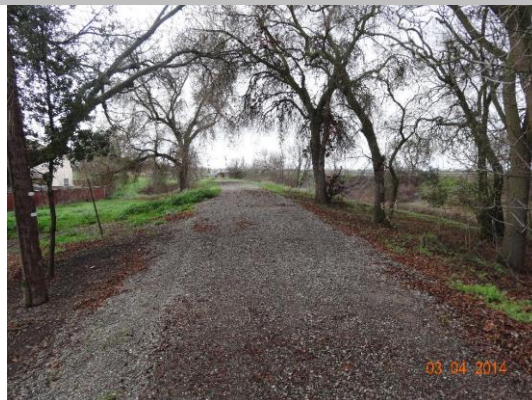
Photo 2 of 2 : UCIP\_FA\_2016\_31903\_58221.jpg

Overview of levee crown looking at crossing.

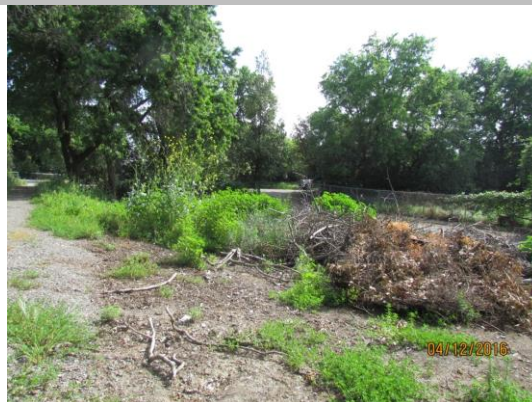
Photo 1 of 1 : FA\_2016\_NA0022\_350\_29\_20160913\_00028.jpg

View of the pruning pile looking downstream. Spring 2016.

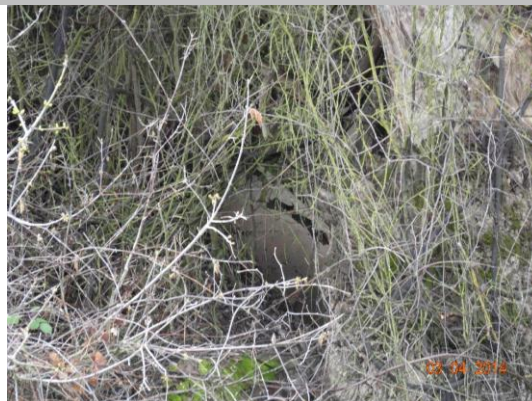
Photo 1 of 2 : UCIP\_FA\_2016\_31904\_58228.jpg

LM Start	0.21	Rating **	M	Issue No.	397
LM End	0.21	Issue Type +	En	Location *	LS
Category	Supplemental			GPS Latitude/Longitude	
				Start	End
Item	DWR UCIP Field Study			38.801280 °	38.801280 °
				-121.722000 °	-121.722000 °
DWR ID					
Comment Code					
Inspector Comment					
FS_ID:31904 DS_ID:19516 EP_NO: N/A Repair Type: Non-Urgent Crossing Status: Indicator Found UCIP Comments: Need to properly abandon per Title 23 if corssing is no longer used--debris inside concrete box and near site. Need to contact owner. FIELD_STRUCT_DESC: 48-inch corrugated metal pipe through the levee, 14.5 feet below the crown. Slide gate in concrete box on the waterside (WS) bank. (Automatic Board Order (ABO) issued as Permit No. unknown, 1976 - Wallace) [Additional Reference(s): DWR Levee Log, 1990 and 2005] FS Date: 3/4/2014

Pipe section with holes abandoned on waterward side.

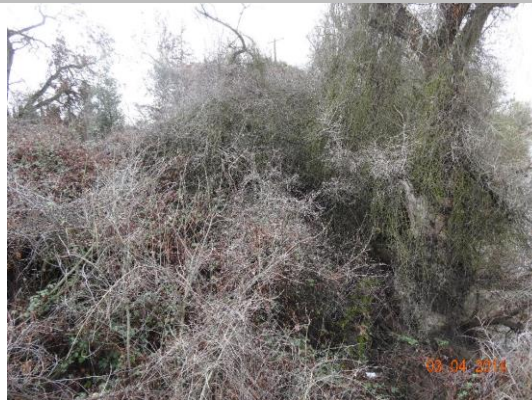
Photo 2 of 2 : UCIP\_FA\_2016\_31904\_58227.jpg

View of waterward toe photo taken from bridge.

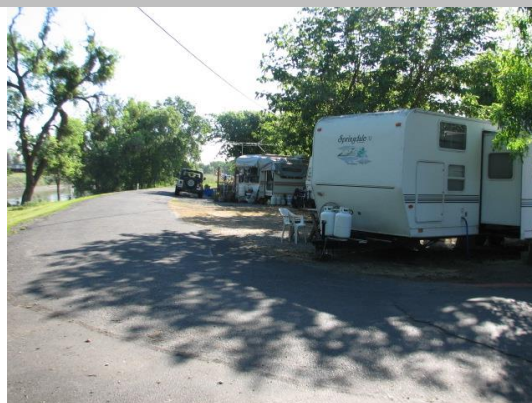
Photo 2 of 2 : FA\_2016\_NA0022\_350\_28\_20160913\_00027.jpg

Trailers on the crown of the levee. Spring 2014

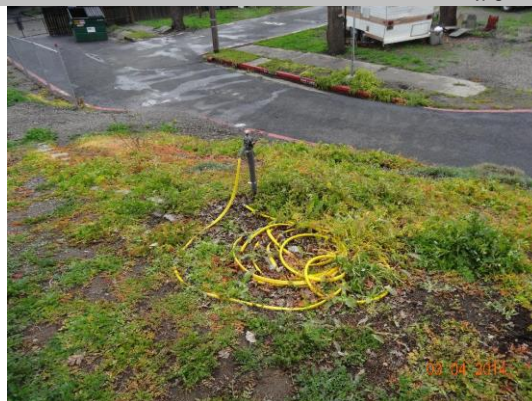
Photo 1 of 2 : UCIP\_FA\_2016\_45403\_60805.jpg

FS\_ID:45403  
DS\_ID:19513  
EP\_NO: 9424  
Repair Type: Non-Urgent  
Crossing Status: Indicator Found  
UCIP Comments: Unable to determine alignment of crossing--it's either through levee or along landward side. It appears that the waterline goes along landward side. Need to contact owner to obtain additional information about crossing. 2 inch metal pipe sticking out at the waterward berm edge.  
FIELD\_STRUCT\_DESC: Water pipe through the levee at an unknown depth below the crown. Faucets in the landside (LS) slope. (Automatic Board Order (ABO) issued as Permit No. 9424, 1974 - Ivey). [Additional Reference(s): DWR Levee Log, 1990 and 2005].  
FS Date: 3/4/2014

Spigot located on landward side.

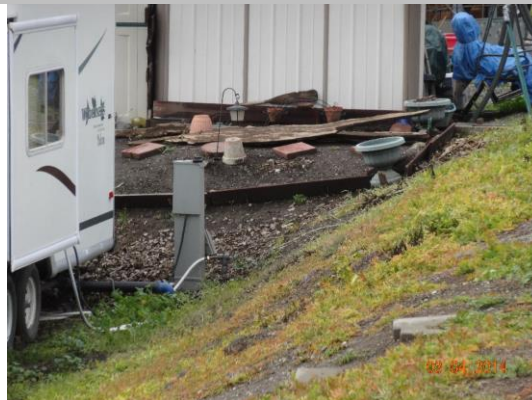
Photo 2 of 2 : UCIP\_FA\_2016\_45403\_60804.jpg

Spigot located on landward toe.

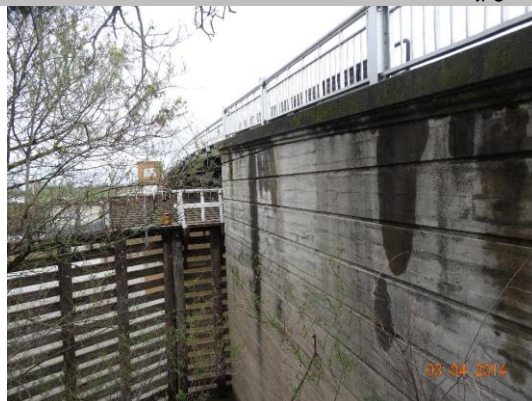
Photo 2 of 2 : UCIP\_FA\_2016\_31906\_58237.jpg

FS\_ID:31906  
DS\_ID:19534  
EP\_NO: 17016  
Repair Type: Non-Urgent  
Crossing Status: Indicator Found  
UCIP Comments: Unable to confirm crossing alignment--steel pipe visible on waterward side however, unable to confirm if crossing is the same one found during field confirmation. Need to contact owner to verify alignment and status of crossing. Slope was too steep to verify and obtain additional information about pipe.  
FIELD\_STRUCT\_DESC: Three 2-inch and three 1.5-inch fiber optic conduits through the levee, encased in a single high-density polyethylene (HDPE) conduit, 30-feet below the levee crown. Concrete caps on both ends of the casing, on the landside (LS) and waterside (WS). Voids in the HDPE conduit grouted. (Permit No. 17016, 2000 - Pacific Fiber Link, LLC).  
FS Date: 3/4/2014

No pipe attached along bridge.

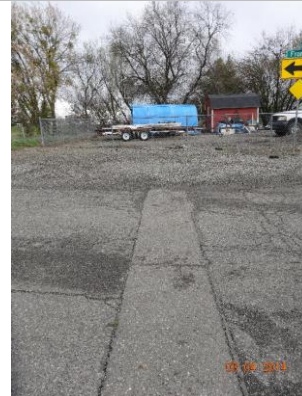
Photo 2 of 2 : UCIP\_FA\_2016\_31627\_57880.jpg

LM Start	0.51	Rating **	M	Issue No.	406
LM End	0.51	Issue Type +	En	Location *	WS
Category	Supplemental			GPS Latitude/Longitude	
				Start	End
Item	DWR UCIP Field Study			38.802062 °	38.802062 °
				-121.716740 °	-121.716740 °
DWR ID					
Comment Code					
Inspector Comment					
FS_ID:31627 DS_ID:19544 EP_NO: N/A Repair Type: Non-Urgent Crossing Status: Indicator Found UCIP Comments: Unable to confirm if signs of crossing are for the same crossing listed here. Need to contact owner and determine additional information about crossing. Also found is service box for water line--need permit and alignment confirmation. FIELD_STRUCT_DESC: 10-inch steel pipe through the levee at an unknown depth below the crown. [Additional Reference(s): DWR Levee Log, 1990 and 2005. USACE Sacramento O&M Manual Unit No. 127, June 1953, (Station 285+27)]. FS Date: 3/4/2014

View of waterward side. Alignment is visible on paved road.

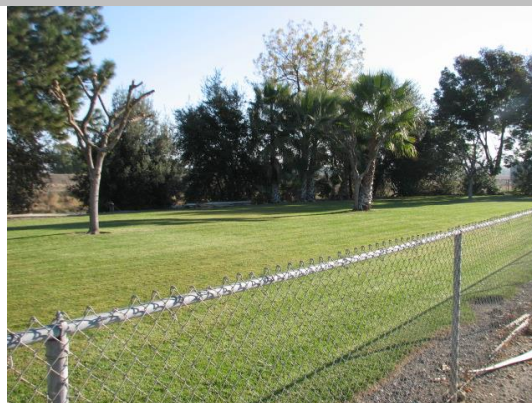
Photo 1 of 1 : FA\_2016\_NA0022\_350\_24\_20160913\_00021.jpg

LM Start	0.53	Rating **	C	Issue No.	69
LM End	0.53	Issue Type +	Ma	Location *	CR
Category	Earthen Levee			GPS Latitude/Longitude	
				Start	End
Item	Crown Surface / Depressions / Rutting			38.801950 °	38.801950 °
				-121.716299 °	-121.716299 °
DWR ID	DWR_NA0022_01_f_2015_69				
Comment Code					
C2 : Repair depressions or ruts in the crown or slope.					
Inspector Comment

The lawn area is on the levee waterside and crown. Fall 2013

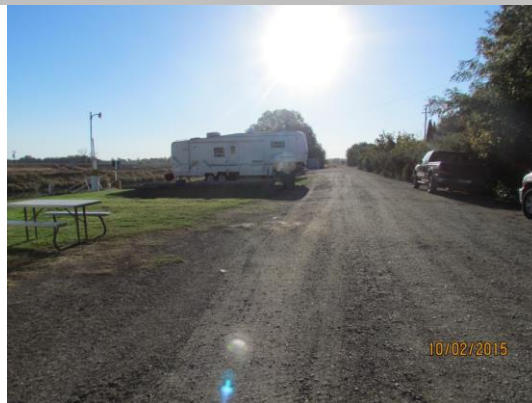
Photo 1 of 1 : FA\_2016\_NA0022\_350\_23\_20160913\_00020.jpg

LM Start	0.55	Rating **	M	Issue No.	408
LM End	0.55	Issue Type +	En	Location *	WS
Category	Supplemental			GPS Latitude/Longitude	
				Start	End
Item	DWR UCIP Field Study			38.801855 °	38.801855 °
				-121.716003 °	-121.716003 °
DWR ID					
Comment Code					
Inspector Comment					
FS_ID:38995 DS_ID:19553 EP_NO: 17649 Repair Type: Non-Urgent Crossing Status: Not Found UCIP Comments: 1 inch line visible on landward side (38.801855, -121.716003) unable to confirm if line is the line authorized. Need to contact owner to confirm installation and size. FIELD_STRUCT_DESC: 2 of 2: 1.5-inch water line of unknown material through the levee, 2 feet below the levee crown. (Permit No. 17649, 2004 - Rose) FS Date: 3/4/2014

View of the Yacht club on the crown of the levee looking downstream.  
Fall 2015.

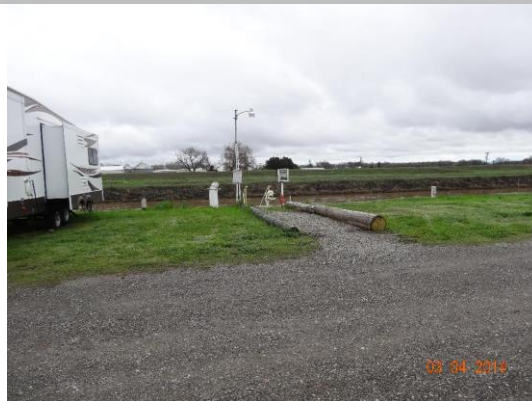
Photo 1 of 2 : UCIP\_FA\_2016\_38188\_69562.jpg

Comment Code					
Inspector Comment					
FS_ID:38188					
DS_ID:19519					
EP_NO: N/A					
Repair Type: Non-Urgent					
Crossing Status: Indicator Found					
UCIP Comments: Unable to find any signs of crossing on waterward side. Signs of concrete riser visible on landward side. If crossing is abandoned owner will need to coordinate with the Central Valley Flood Protection Board (CVFPB) for Title 23 requirements.					
FIELD_STRUCT_DESC: 10-inch pipe of unknown material through the levee, 3.3 feet below the crown. Plate welded on waterside (WS) end in 1975. 24-inch concrete riser on the landside (LS). [Additional Reference(s): DWR Levee Log, 1990 and 2005].					
FS Date: 3/4/2014

View of waterward side.

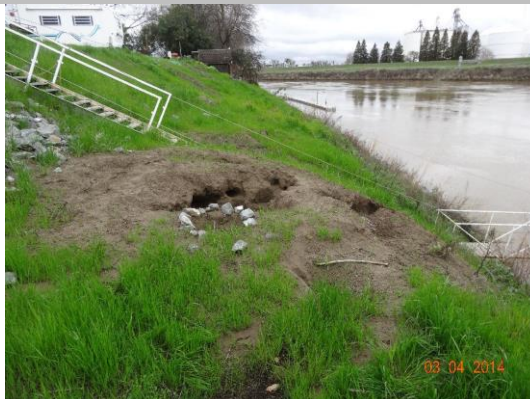
Photo 2 of 2 : UCIP\_FA\_2016\_38188\_69560.jpg

Item	DWR UCIP Field Study			38.801798 °		38.801798 °
				-121.715584 °		-121.715584 °
DWR ID						
Comment Code						
Inspector Comment						
FS_ID:38188						
DS_ID:19519						
EP_NO: N/A						
Repair Type: Non-Urgent						
Crossing Status: Indicator Found						
UCIP Comments: Unable to find any signs of crossing on waterward side. Signs of concrete riser visible on landward side. If crossing is abandoned owner will need to coordinate with the Central Valley Flood Protection Board (CVFPB) for Title 23 requirements.						
FIELD_STRUCT_DESC: 10-inch pipe of unknown material through the levee, 3.3 feet below the crown. Plate welded on waterside (WS) end in 1975. 24-inch concrete riser on the landside (LS). [Additional Reference(s): DWR Levee Log, 1990 and 2005].						
FS Date: 3/4/2014

View of waterward slope. Large hole visible on waterward side.

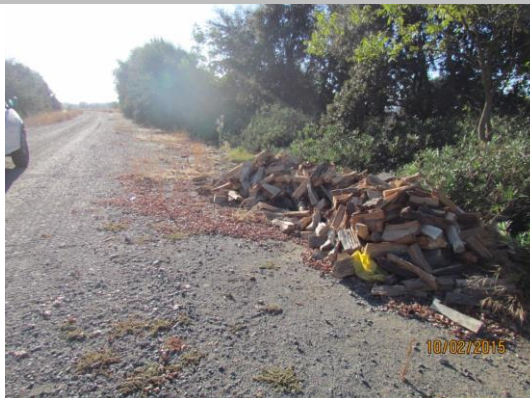
Photo 1 of 1 : FA\_2016\_NA0022\_350\_70\_20160913\_00049.jpg

View of the firewood on the landward side of the levee looking downstream. Fall 2015.

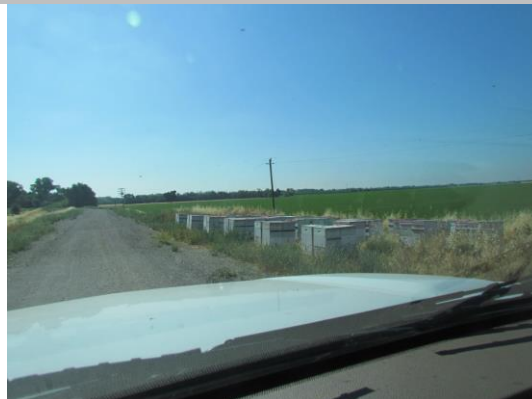
Photo 1 of 1 : FA\_2016\_NA0022\_350\_73\_20160913\_00050.jpg

View of the beehives on the landward side of the levee looking downstream. Spring 2015.

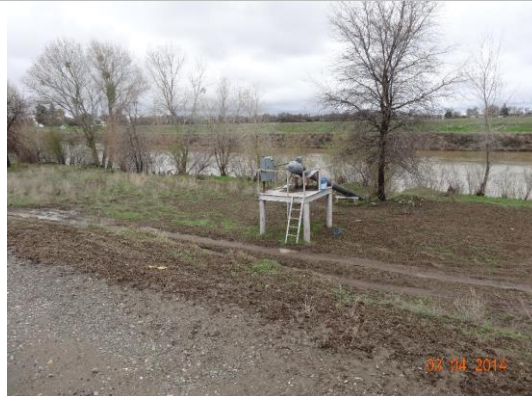
Photo 1 of 2 : UCIP\_FA\_2016\_31969\_58410.jpg

LM Start	0.93	Rating **	M	Issue No.	404
LM End	0.93	Issue Type +	En	Location *	LS
Category	Supplemental			GPS Latitude/Longitude	
				Start	End
Item	DWR UCIP Field Study			38.800200 °	38.800200 °
				-121.709258 °	-121.709258 °
DWR ID					
Comment Code					
Inspector Comment					
FS_ID:31969 DS_ID:19540 EP_NO: N/A Repair Type: Non-Urgent Crossing Status: Found UCIP Comments: Pipe section on waterward side appears to have been removed and reinstalled--Need to contact owner to obtain additional information regarding work completed. FIELD_STRUCT_DESC: 14-inch steel irrigation pipe through the levee, 4.6 feet below the crown. Pump and valve are located on the waterside (WS) bank. Pipe and pump were removed and replaced under Permit No. 3798 (1962) SEE DS_ID 19521. [Additional Reference(s): USACE Sacramento O&M Manual Unit No. 127, June 1953, (Station 266+72.2)]. FS Date: 3/4/2014

View of waterward side.

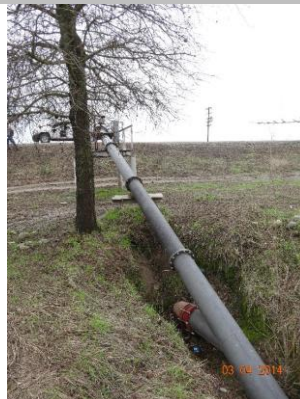
Photo 2 of 2 : UCIP\_FA\_2016\_31969\_58409.jpg

Item	DWR UCIP Field Study			38.800200 °		38.800200 °
				-121.709258 °		-121.709258 °
DWR ID						
Comment Code						
Inspector Comment						
FS_ID:31969						
DS_ID:19540						
EP_NO: N/A						
Repair Type: Non-Urgent						
Crossing Status: Found						
UCIP Comments: Pipe section on waterward side appears to have been removed and reinstalled--Need to contact owner to obtain additional information regarding work completed.						
FIELD_STRUCT_DESC: 14-inch steel irrigation pipe through the levee, 4.6 feet below the crown. Pump and valve are located on the waterside (WS) bank. Pipe and pump were removed and replaced under Permit No. 3798 (1962) SEE DS_ID 19521. [Additional Reference(s): USACE Sacramento O&M Manual Unit No. 127, June 1953, (Station 266+72.2)].						
FS Date: 3/4/2014

Pipe located on waterward side.

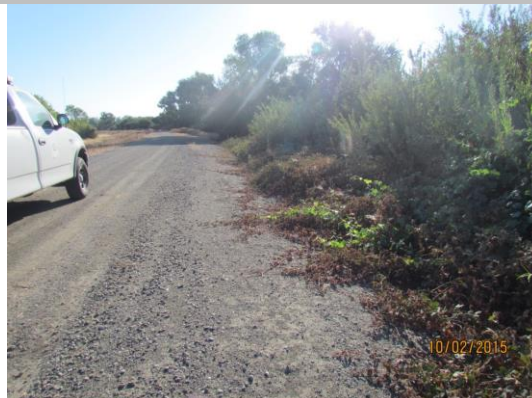
Photo 1 of 1 : FA\_2016\_NA0022\_350\_21\_20160913\_00018.jpg

View of the vegetation on the landward side of the levee looking downstream. Fall 2015.

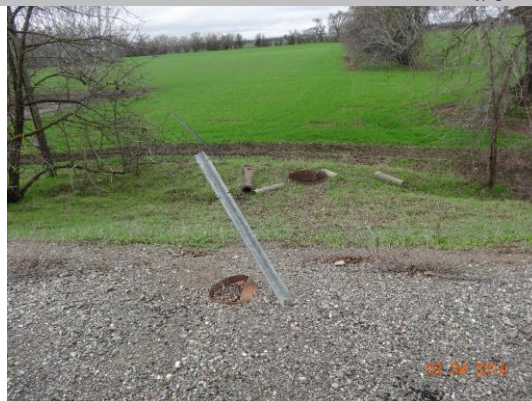
Photo 1 of 2 : UCIP\_FA\_2016\_31912\_58261.jpg

FS\_ID:31912  
DS\_ID:19522  
EP\_NO: 6296  
Repair Type: Non-Urgent  
Crossing Status: Found  
UCIP Comments: Siphon breaker housing on landward slope unit damaged and debris scattered on landward side. Unable to determine if crossing is still in use. Need to contact owner to determine status of crossing.  
FIELD\_STRUCT\_DESC: 12-inch (not 14 inch as indicated in desk study) irrigation pipe through the levee, 11.8 feet below the crown. 1.25 electrical conduit through the levee. Electrical control panel on waterside (WS) slope. Slant pump, mounted on steel structure on the WS bank. Siphon breaker on the landside (LS) shoulder. Standard corrugated metal cutoff wall around pipe at centerline of levee. Pipe extends from pump to existing irrigation ditch at LS toe. (Permit No. 6296, 1968 - Collier) [Additional Reference(s): DWR Levee Log, 1990 and 2005].  
FS Date: 3/4/2014

View of landward side.

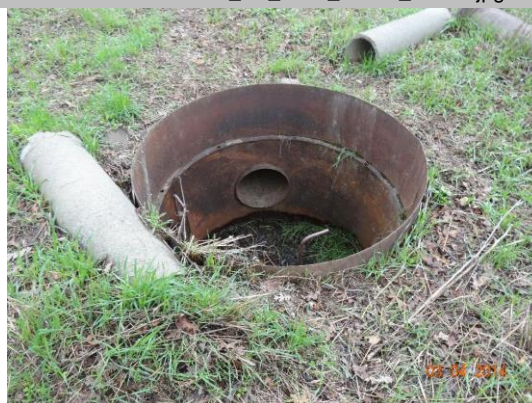
Photo 2 of 2 : UCIP\_FA\_2016\_31912\_58260.jpg

Riser on landward toe.

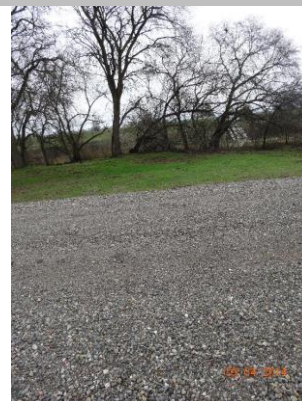
Photo 1 of 2 : UCIP\_FA\_2016\_38190\_69563.jpg

LM Start	1.75	Rating **	M	Issue No.	413
LM End	1.75	Issue Type +	En	Location *	WS
Category	Supplemental			GPS Latitude/Longitude	
				Start	End
Item	DWR UCIP Field Study			38.797928 °	38.797928 °
				-121.697992 °	-121.697992 °
DWR ID					
Comment Code					
Inspector Comment					
FS_ID:38190 DS_ID:19539 EP_NO: N/A Repair Type: Non-Urgent Crossing Status: Indicator Found UCIP Comments: Need to contact owner to determine status of crossing. FIELD_STRUCT_DESC: *ABANDONED* 12-inch (not 18-inch as mentioned in USACE O&M manual) corrugated metal irrigation pipe through the levee. Gate valve in pumphouse on waterside (WS) (no pump house found). Pipe was abandoned prior to 1968. [Additional Reference(s): USACE Sacramento O&M Manual Unit No. 127, June 1953, (Station 224+3.5)]. FS Date: 3/4/2014

View of waterward side.

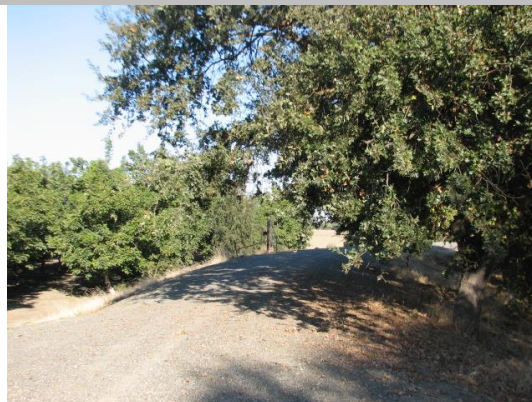
Photo 1 of 1 : FA\_2016\_NA0022\_350\_9\_20160913\_00010.jpg

Trees need to be trimmed up to 12 feet above the crown. Fall 2013

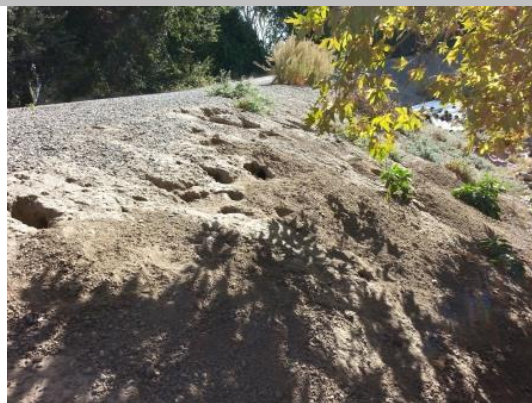
Photo 1 of 3 : FA\_2016\_NA0022\_350\_8\_20161010\_00153.jpg

View from levee toe on animal burrows on LS slope. Fall inspection 10/07/2016.

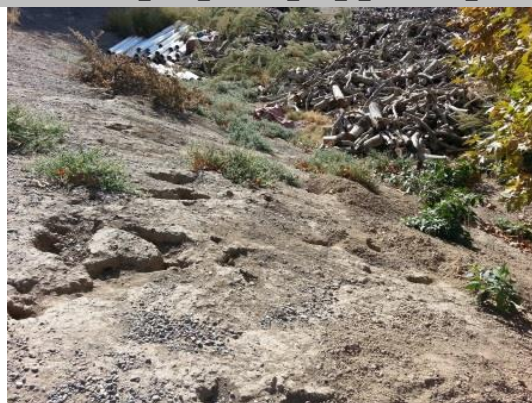
Photo 2 of 3 : FA\_2016\_NA0022\_350\_8\_20161010\_00155.jpg

Another view of the burrows from levee crown. Fall inspection 10/07/2016.

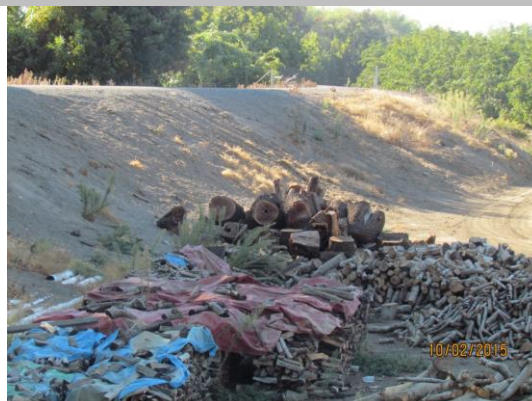
Photo 1 of 1 : FA\_2016\_NA0022\_350\_39\_20160913\_00035.jpg

View of the growing firewood at the toe of the landward side of the levee looking downstream. Fall 2015.

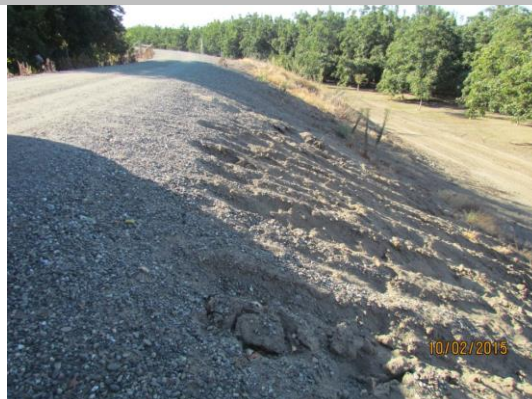
Photo 2 of 2 : FA\_2016\_NA0022\_350\_93\_20160913\_00063.jpg

View of the slope stability on the landward side of the levee looking downstream. Fall 2015.

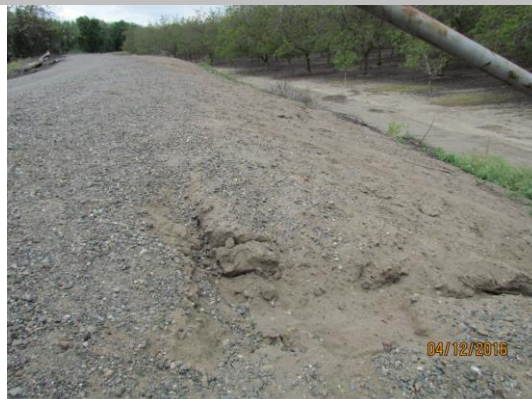
Photo 1 of 2 : FA\_2016\_NA0022\_350\_35\_20160913\_00030.jpg

Perspective view of the erosion on the landward side of the levee. Spring 2016.

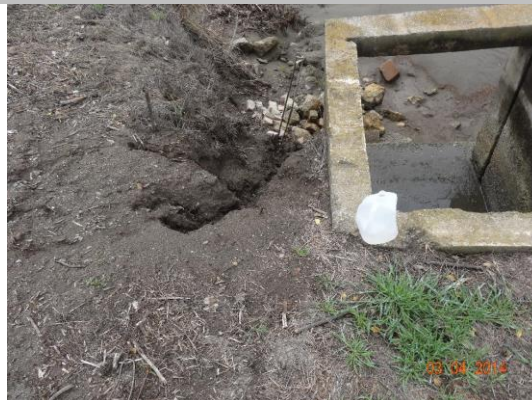
Photo 2 of 2 : UCIP\_FA\_2016\_49982\_57914.jpg

Slope erosion near concrete box.

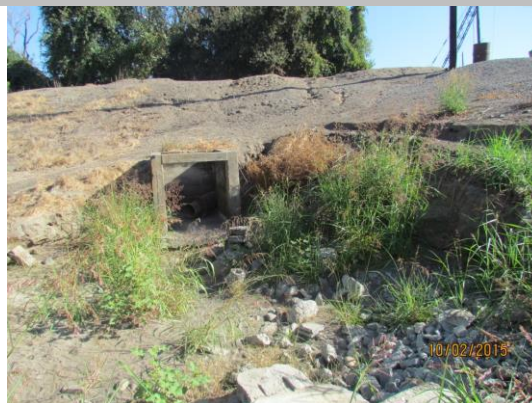
Photo 2 of 3 : FA\_2016\_NA0022\_350\_96\_20160913\_00066.jpg

The erosion is within the levee prism. Fall 2015.

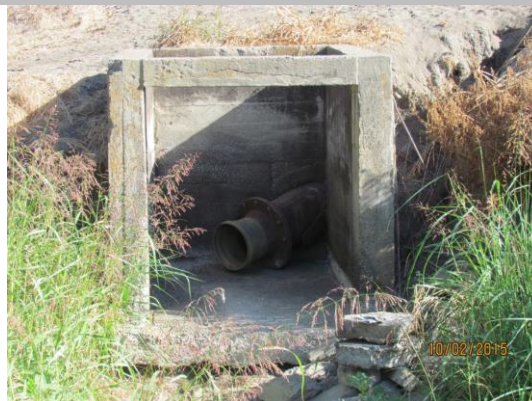
Photo 3 of 3 : FA\_2016\_NA0022\_350\_96\_20160913\_00067.jpg

View of the pipe in the concrete box. Fall 2015.

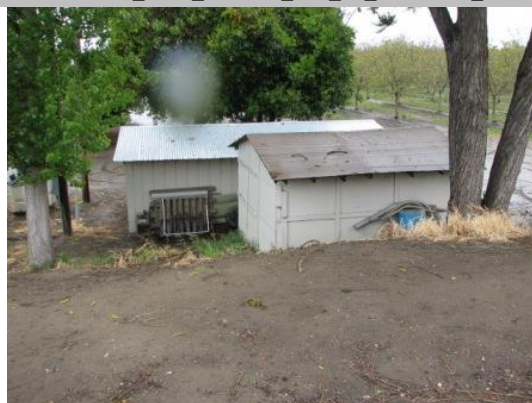
Photo 1 of 1 : FA\_2016\_NA0022\_350\_11\_20160913\_00011.jpg

Garage at toe.

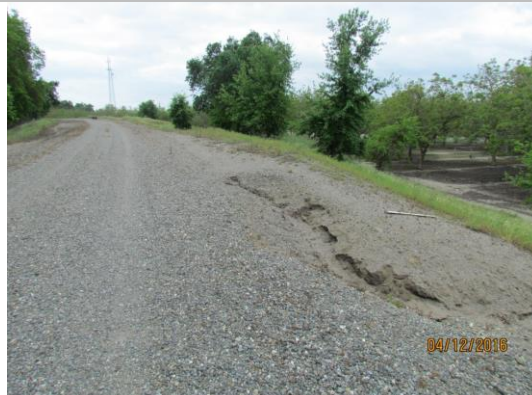
Photo 2 of 2 : FA\_2016\_NA0022\_350\_87\_20160913\_00060.jpg

View of the erosion on the landward side of the levee looking downstream. Spring 2016.

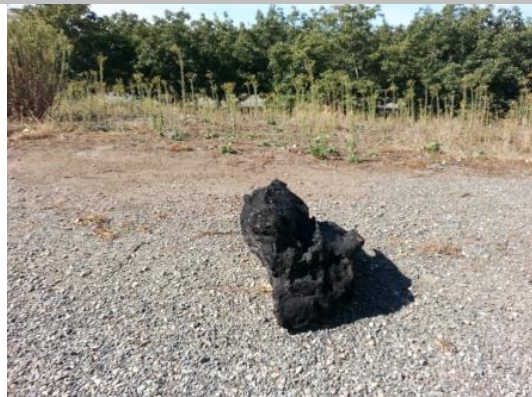
Photo 1 of 1 : FA\_2016\_NA0022\_350\_99\_20161010\_00164.jpg

Burnt piece of tree body on the crown. Fall inspection 10/07/2016.

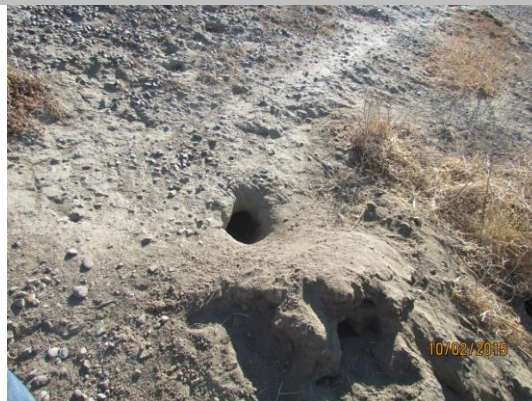
Photo 2 of 2 : FA\_2016\_NA0022\_350\_52\_20160913\_00045.jpg

There are multiple rodent holes in this area. Fall 2015.

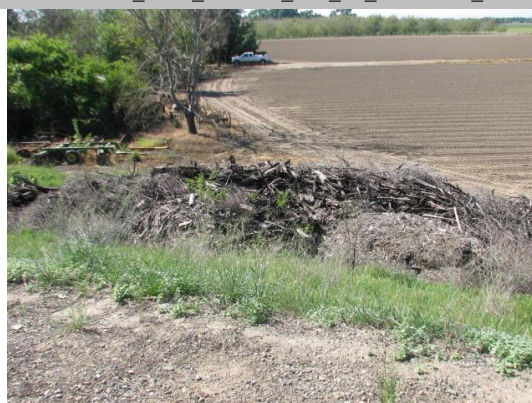
Photo 1 of 1 : FA\_2016\_NA0022\_350\_42\_20160913\_00037.jpg

A large pruning pile near the toe of the levee. Spring 2014

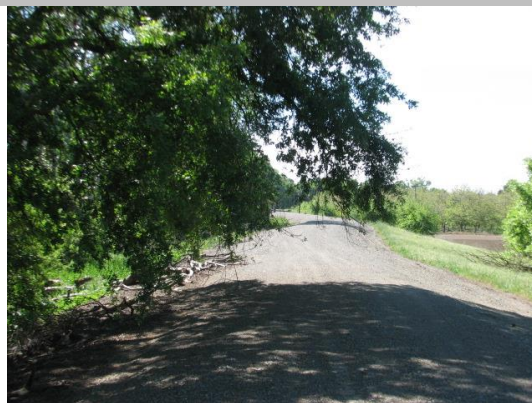
Photo 1 of 1 : FA\_2016\_NA0022\_350\_46\_20160913\_00041.jpg

Trees need to be trimmed up to at least 12 feet above the crown. Spring 2014

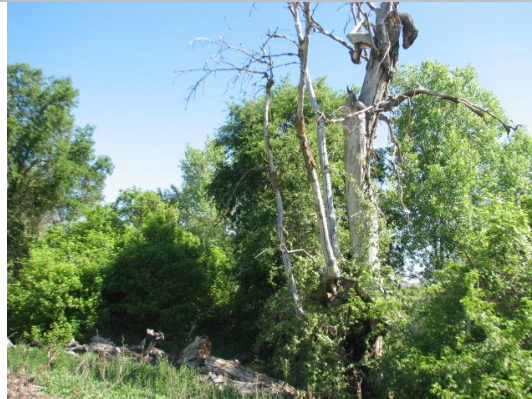
Photo 2 of 2 : FA\_2016\_NA0022\_350\_47\_20160913\_00043.jpg

Some trees have fallen and others are dying and need to be monitored. The trees may pose a threat to the levee. Spring 2014

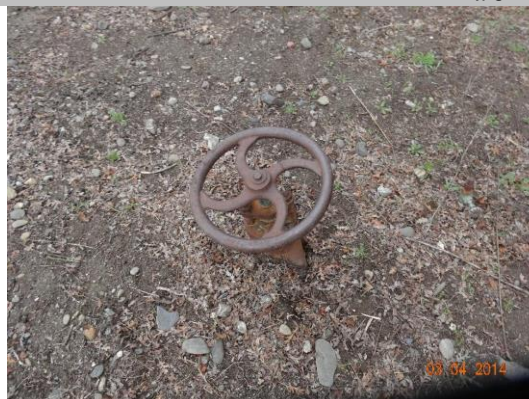
Photo 2 of 2 : UCIP\_FA\_2016\_39858\_71840.jpg

Positive closure device is buried on waterward side.

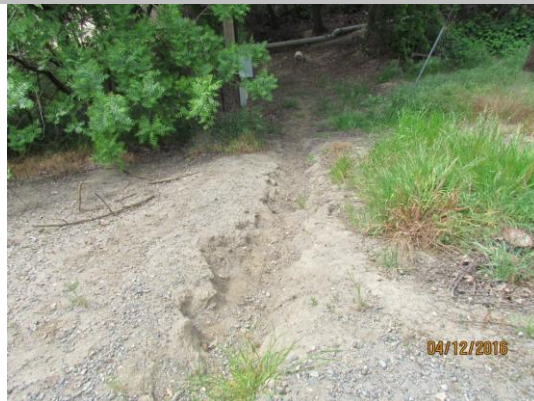
Photo 2 of 3 : FA\_2016\_NA0022\_350\_79\_20160913\_00054.jpg

Dirt stairs has eroded and caused a slope stability. Spring 2016.

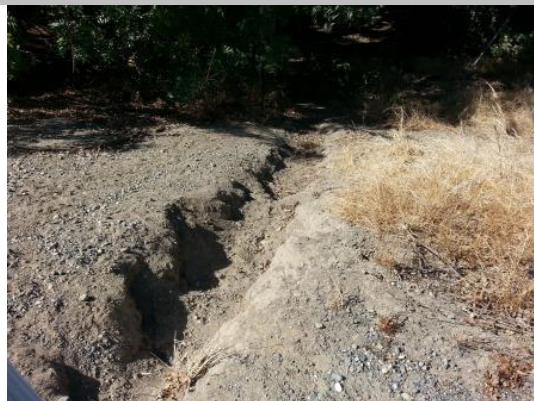
Photo 3 of 3 : FA\_2016\_NA0022\_350\_79\_20161010\_00166.jpg

Stairwell has eroded more creating erosion issue. Fall inspection 10/07/2016.

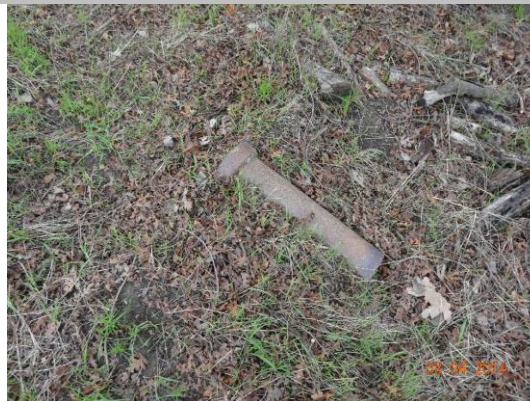
Photo 2 of 2 : UCIP\_FA\_2016\_38996\_69567.jpg

Debris scattered on landward side.

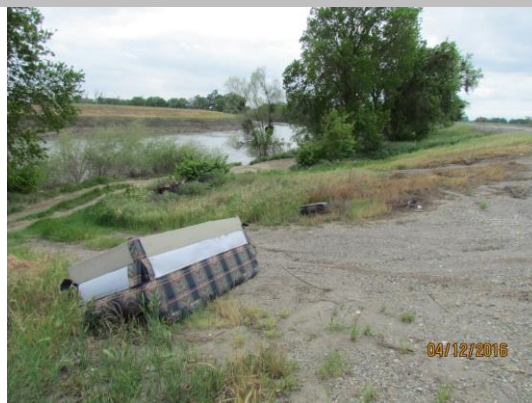
Photo 1 of 1 : FA\_2016\_NA0022\_350\_98\_20160913\_00068.jpg

View of the couch on the waterward side of the levee looking downstream. Spring 2016.

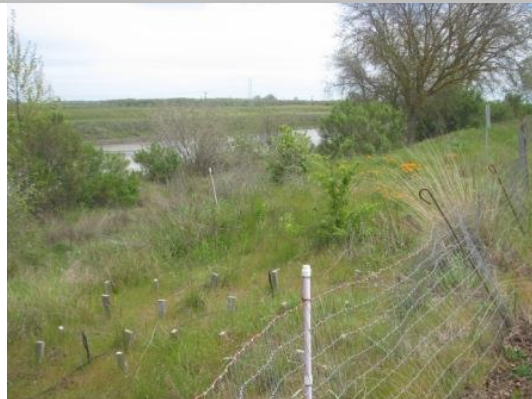
Photo 2 of 2 : FA\_2016\_NA0022\_350\_36\_20160913\_00033.jpg

Fence, irrigation and stakes in the revegetation site.

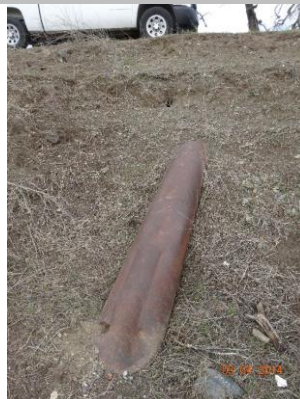
Photo 2 of 2 : UCIP\_FA\_2016\_31986\_58439.jpg

Pipe through levee punctured visible on landward slope.

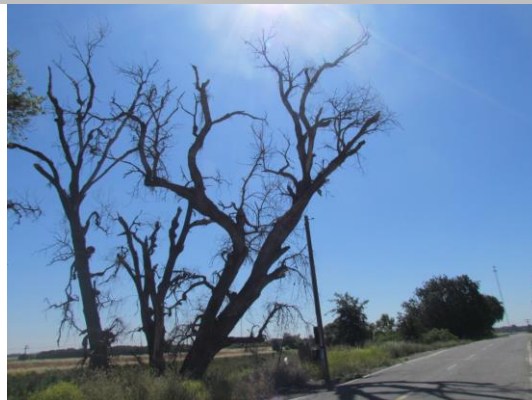
Photo 1 of 1 : FA\_2016\_NA0022\_350\_81\_20160913\_00055.jpg

View of the dying tree on the waterward side of the levee looking downstream. Spring 2015.

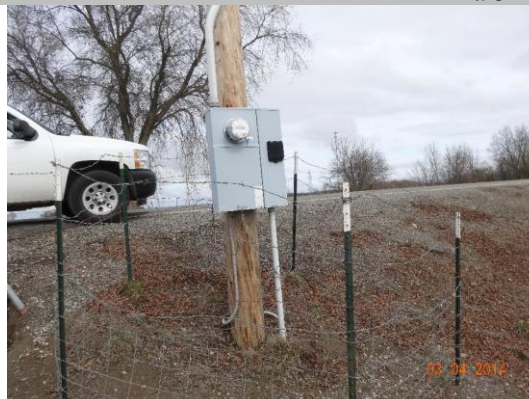
Photo 2 of 2 : UCIP\_FA\_2016\_49983\_69572.jpg

Power pole with conduit line through levee.

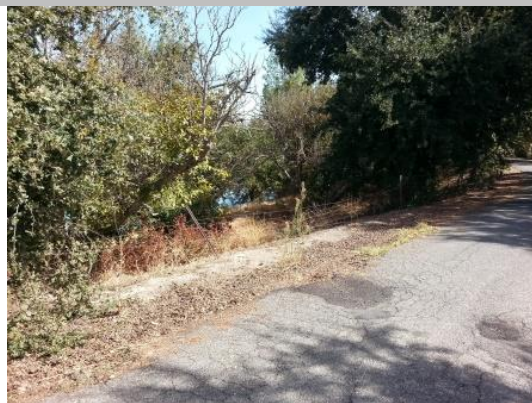
Photo 1 of 1 : FA\_2016\_NA0022\_350\_145\_20161010\_00169.jpg

Fence on WS slope near levee crown. Fall inspection 10/07/2016.

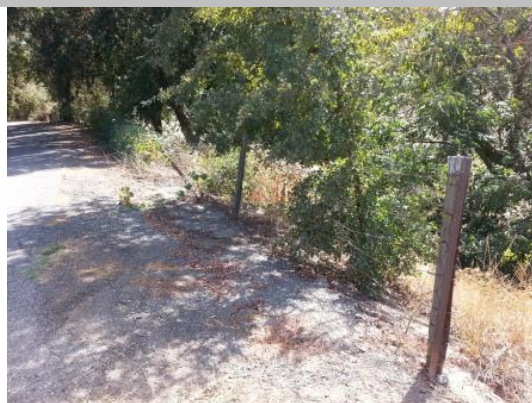
Photo 1 of 1 : FA\_2016\_NA0022\_350\_144\_20161010\_00168.jpg

Fence on LS slope near levee crown. Fall inspection 10/07/2016.

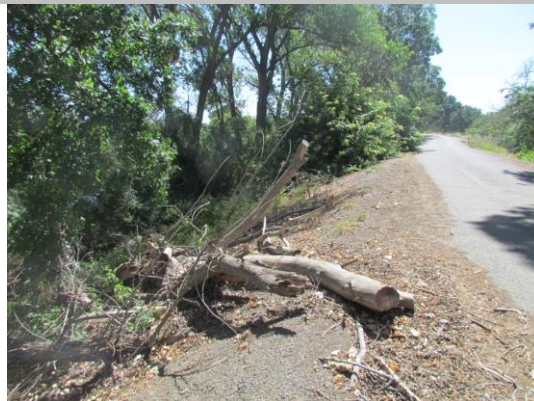
Photo 1 of 1 : FA\_2016\_NA0022\_350\_82\_20160913\_00056.jpg

View of the fallen tree on the waterward side of the levee looking downstream. Spring 2015.

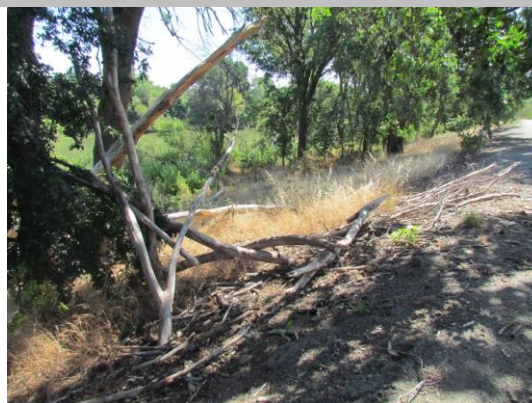
Photo 1 of 1 : FA\_2016\_NA0022\_350\_83\_20160913\_00057.jpg

View of the tree and tree limbs on the waterward side of the levee looking downstream. Spring 2015.

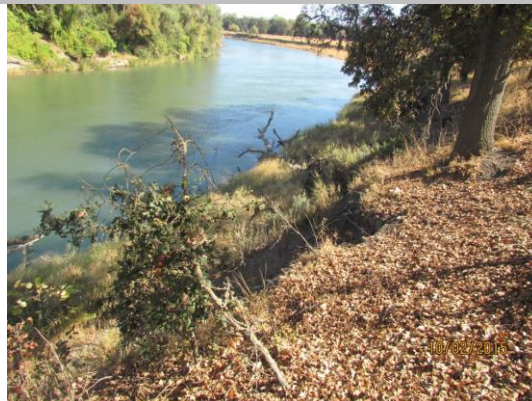
Photo 3 of 3 : FA\_2016\_NA0022\_350\_84\_20160913\_00059.jpg

View of the erosion on the waterward side of the levee looking downstream. Fall 2015.
